MARLIN-ROCKWELL COMPANY
DIVISION OF TRW INC.

M-R-C RESEARCH PROPOSAL NO. 1540
for
GEORGE C. MARSHALL SPACE FLIGHT CENTER
Huntsville, Alabama

"Spin Axis Bearings"

Report - Phase V
Contract No. NAS 8-5441

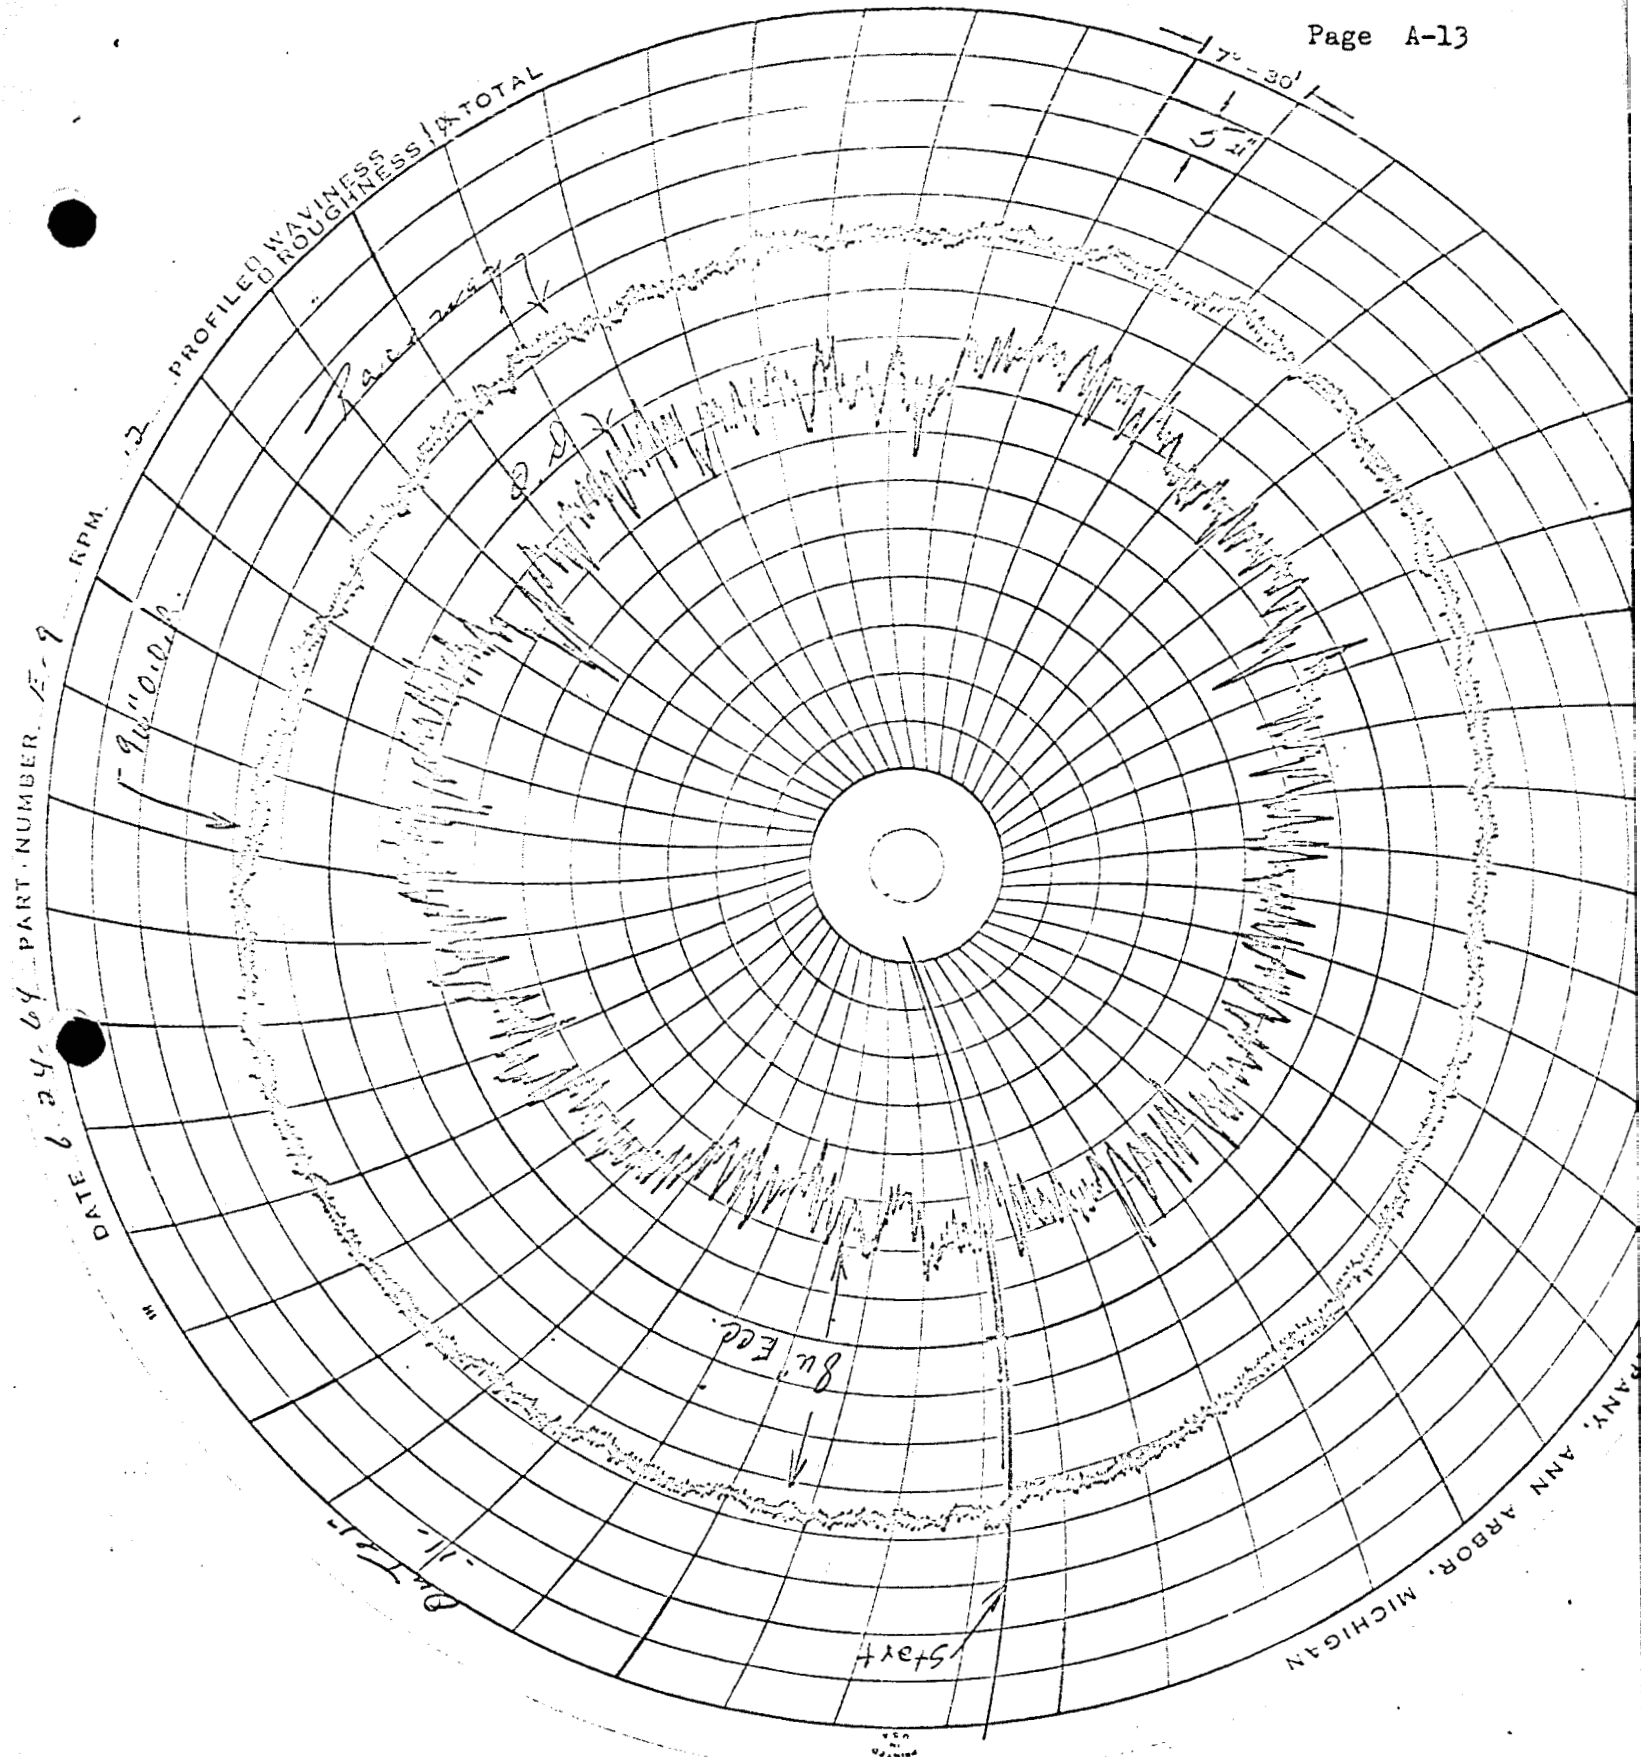
PROFICORDER TRACES OF AN OUTER RACE AND O.D. OF OUTER OF LOT E, BEARING NO. 9

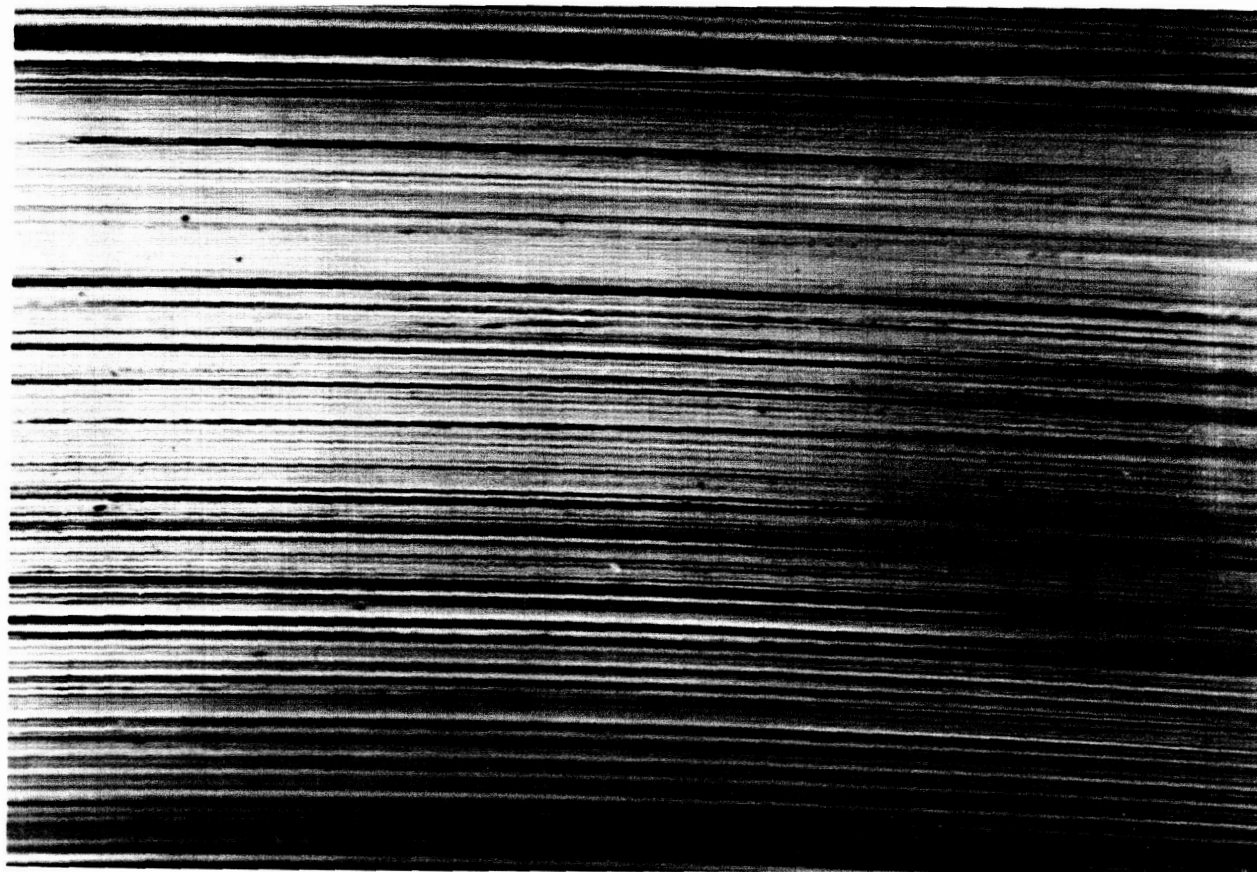
PHOTOGRAPH OF FINISH OF INNER RACE OF
LOT E, BEARING NO. 13 AT 500X MAGNIFICATION

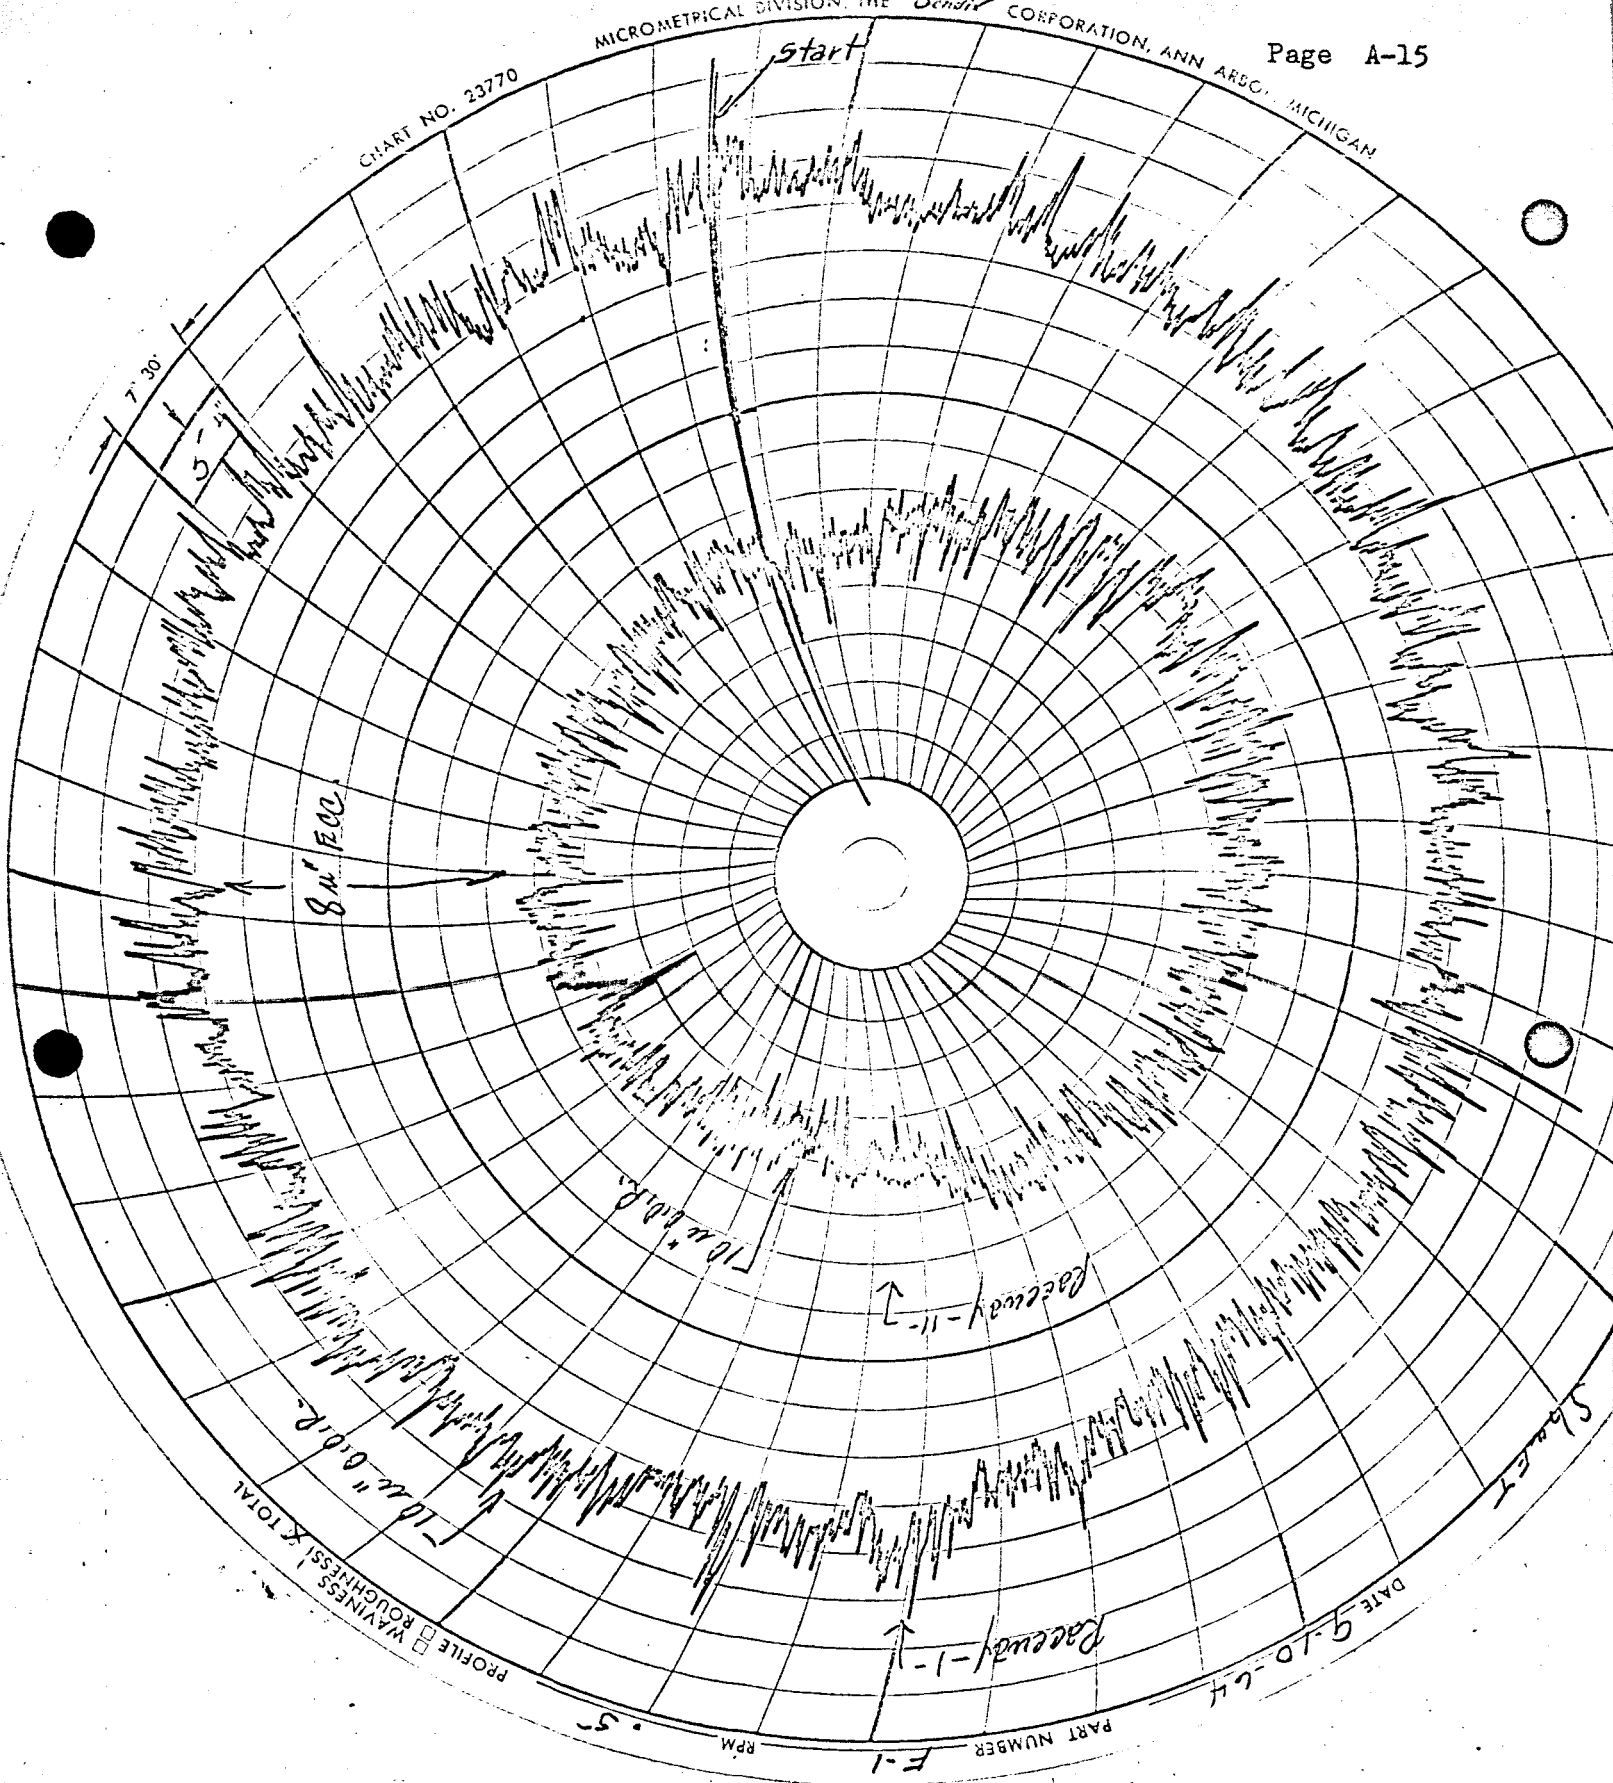
PROFICORDER TRACES OF INNER RACES OF LOT F, BEARING NO. 1

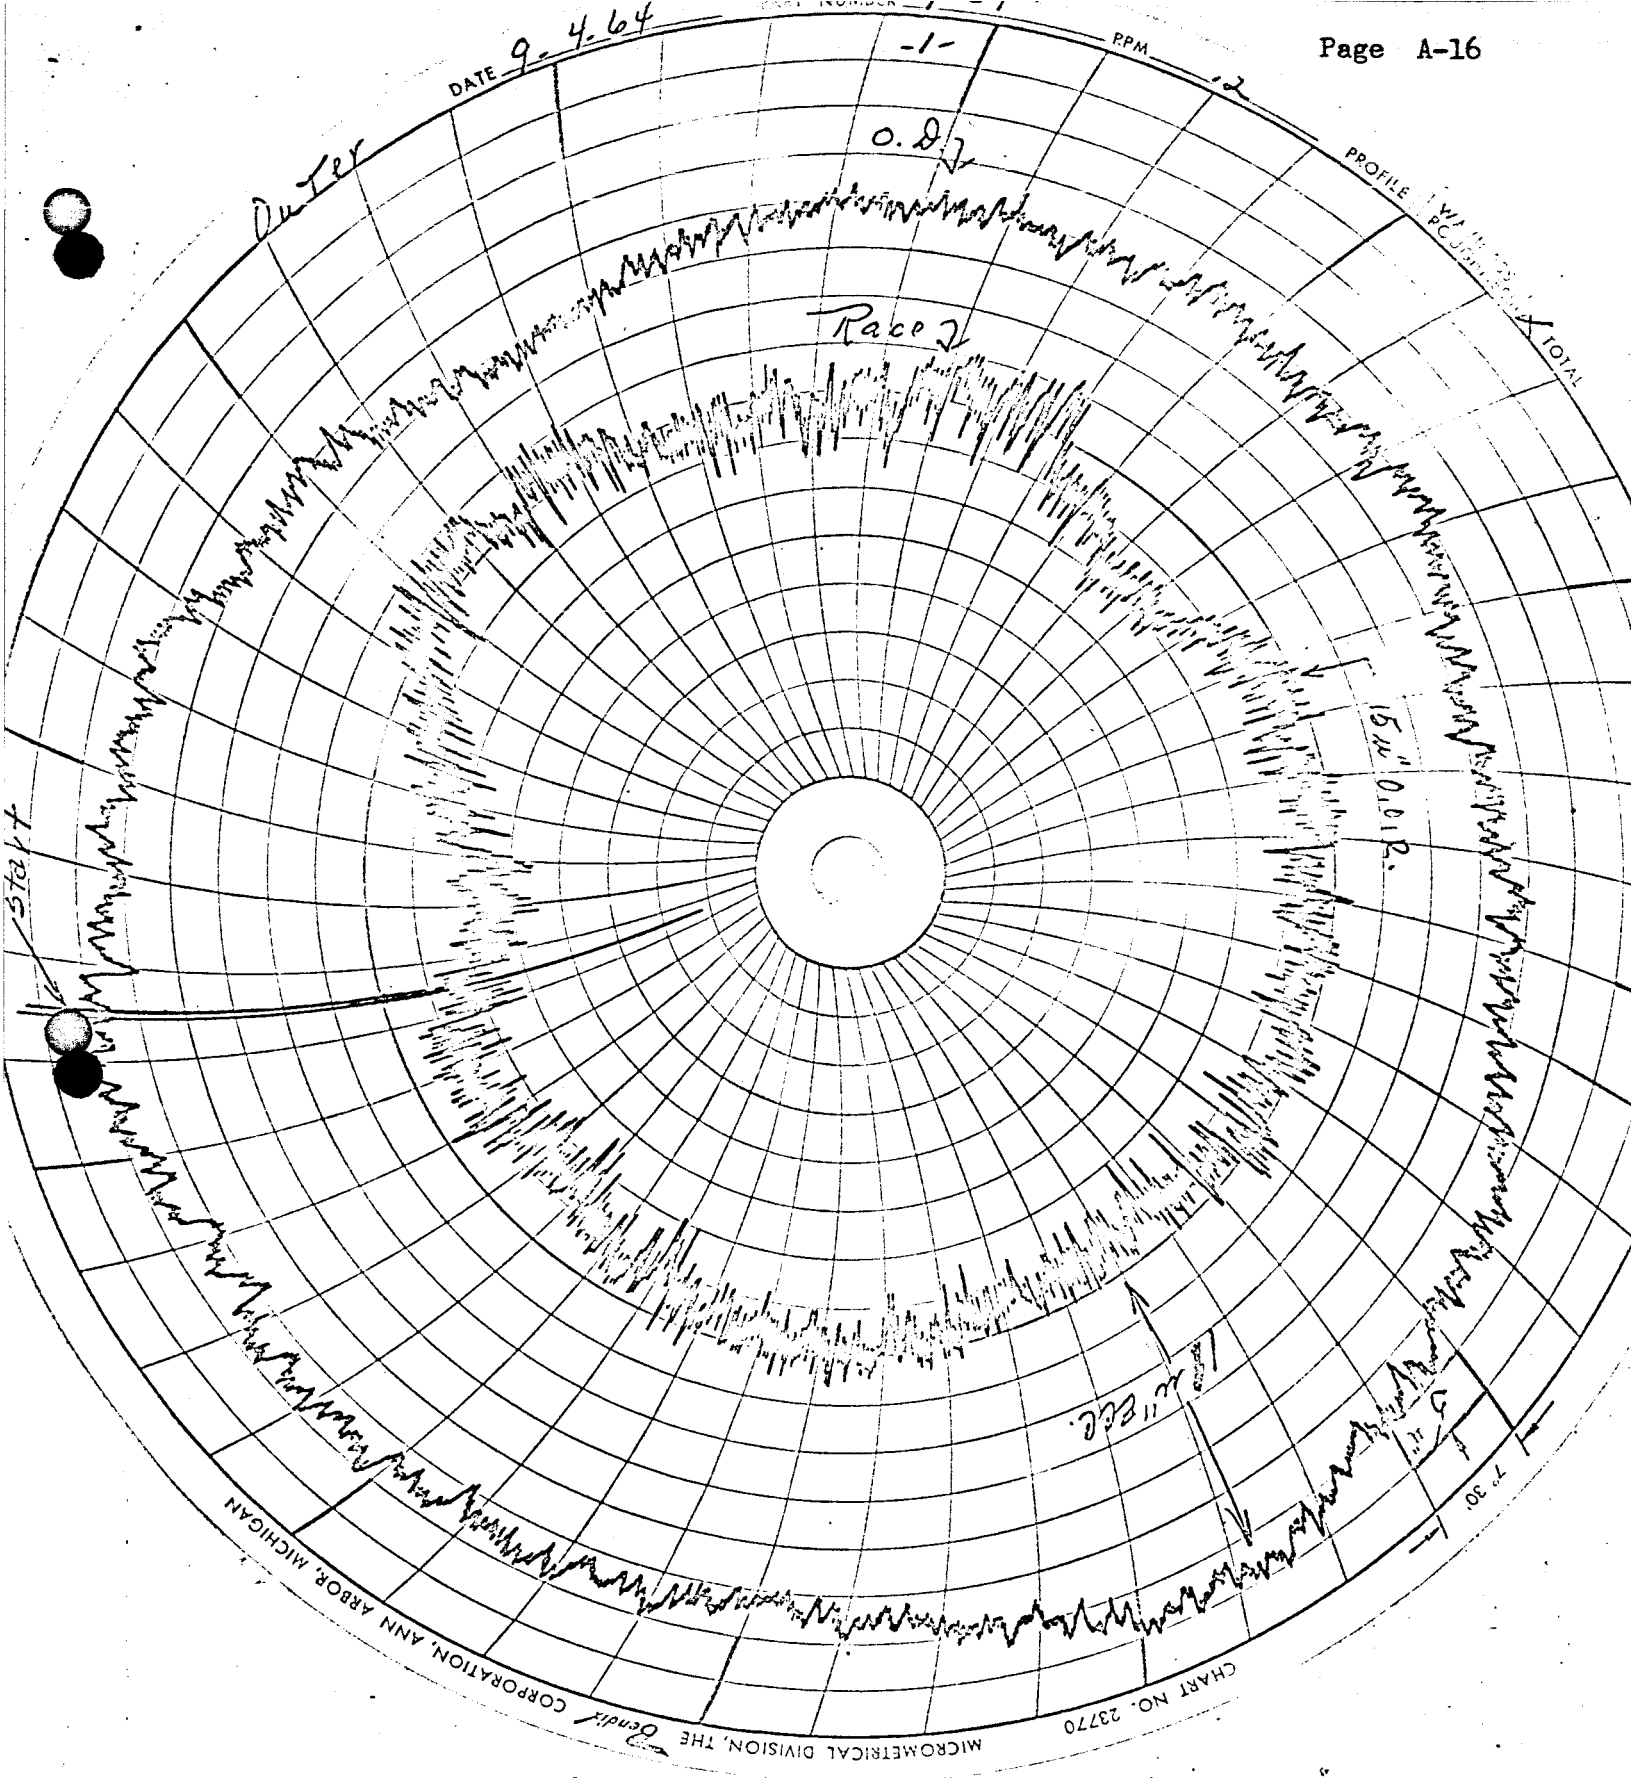
PROFICORDER TRACES OF AN OUTER RACE AND OF O.D. OF OUTER OF
LOT F, BEARING NO. 1

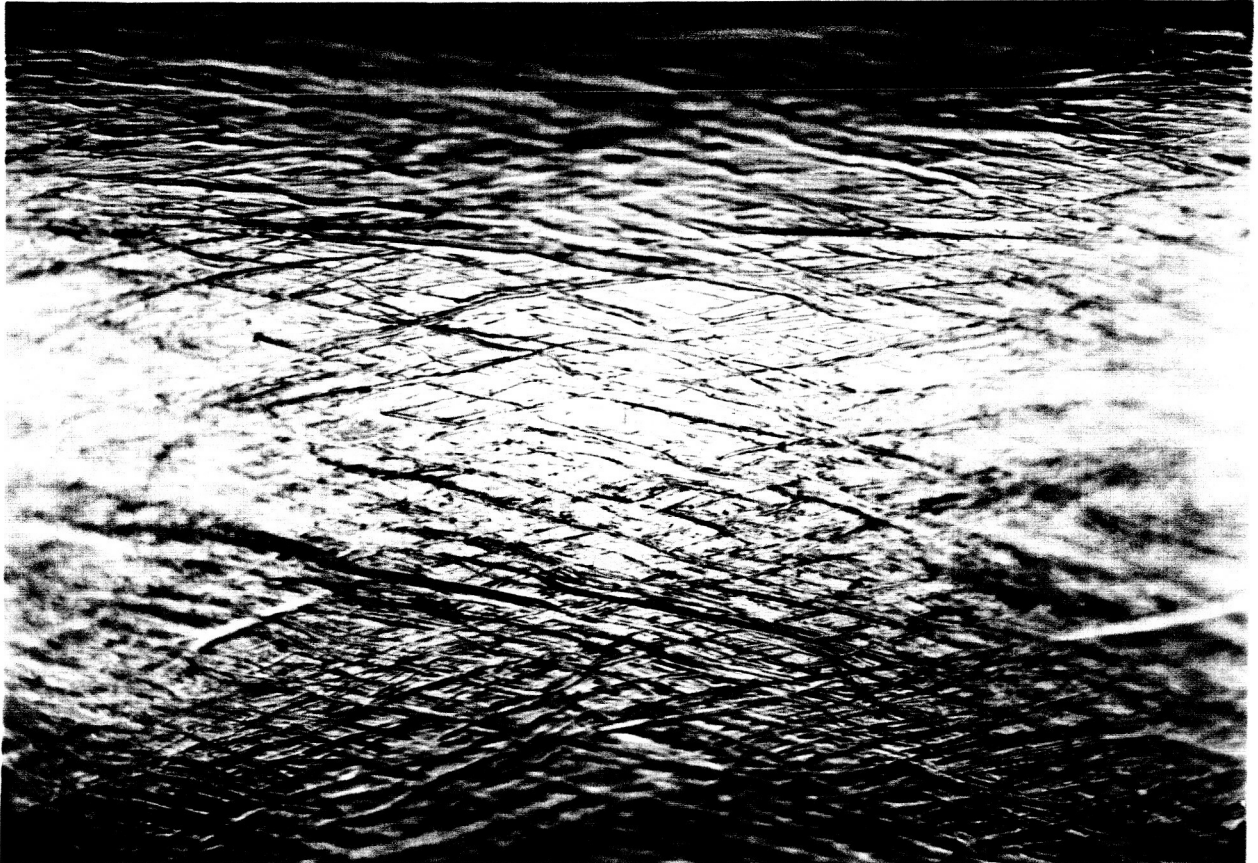
PHOTOGRAPH OF FINISH OF INNER RACE OF
LOT F, BEARING NO. 11 AT 250X MAGNIFICATION

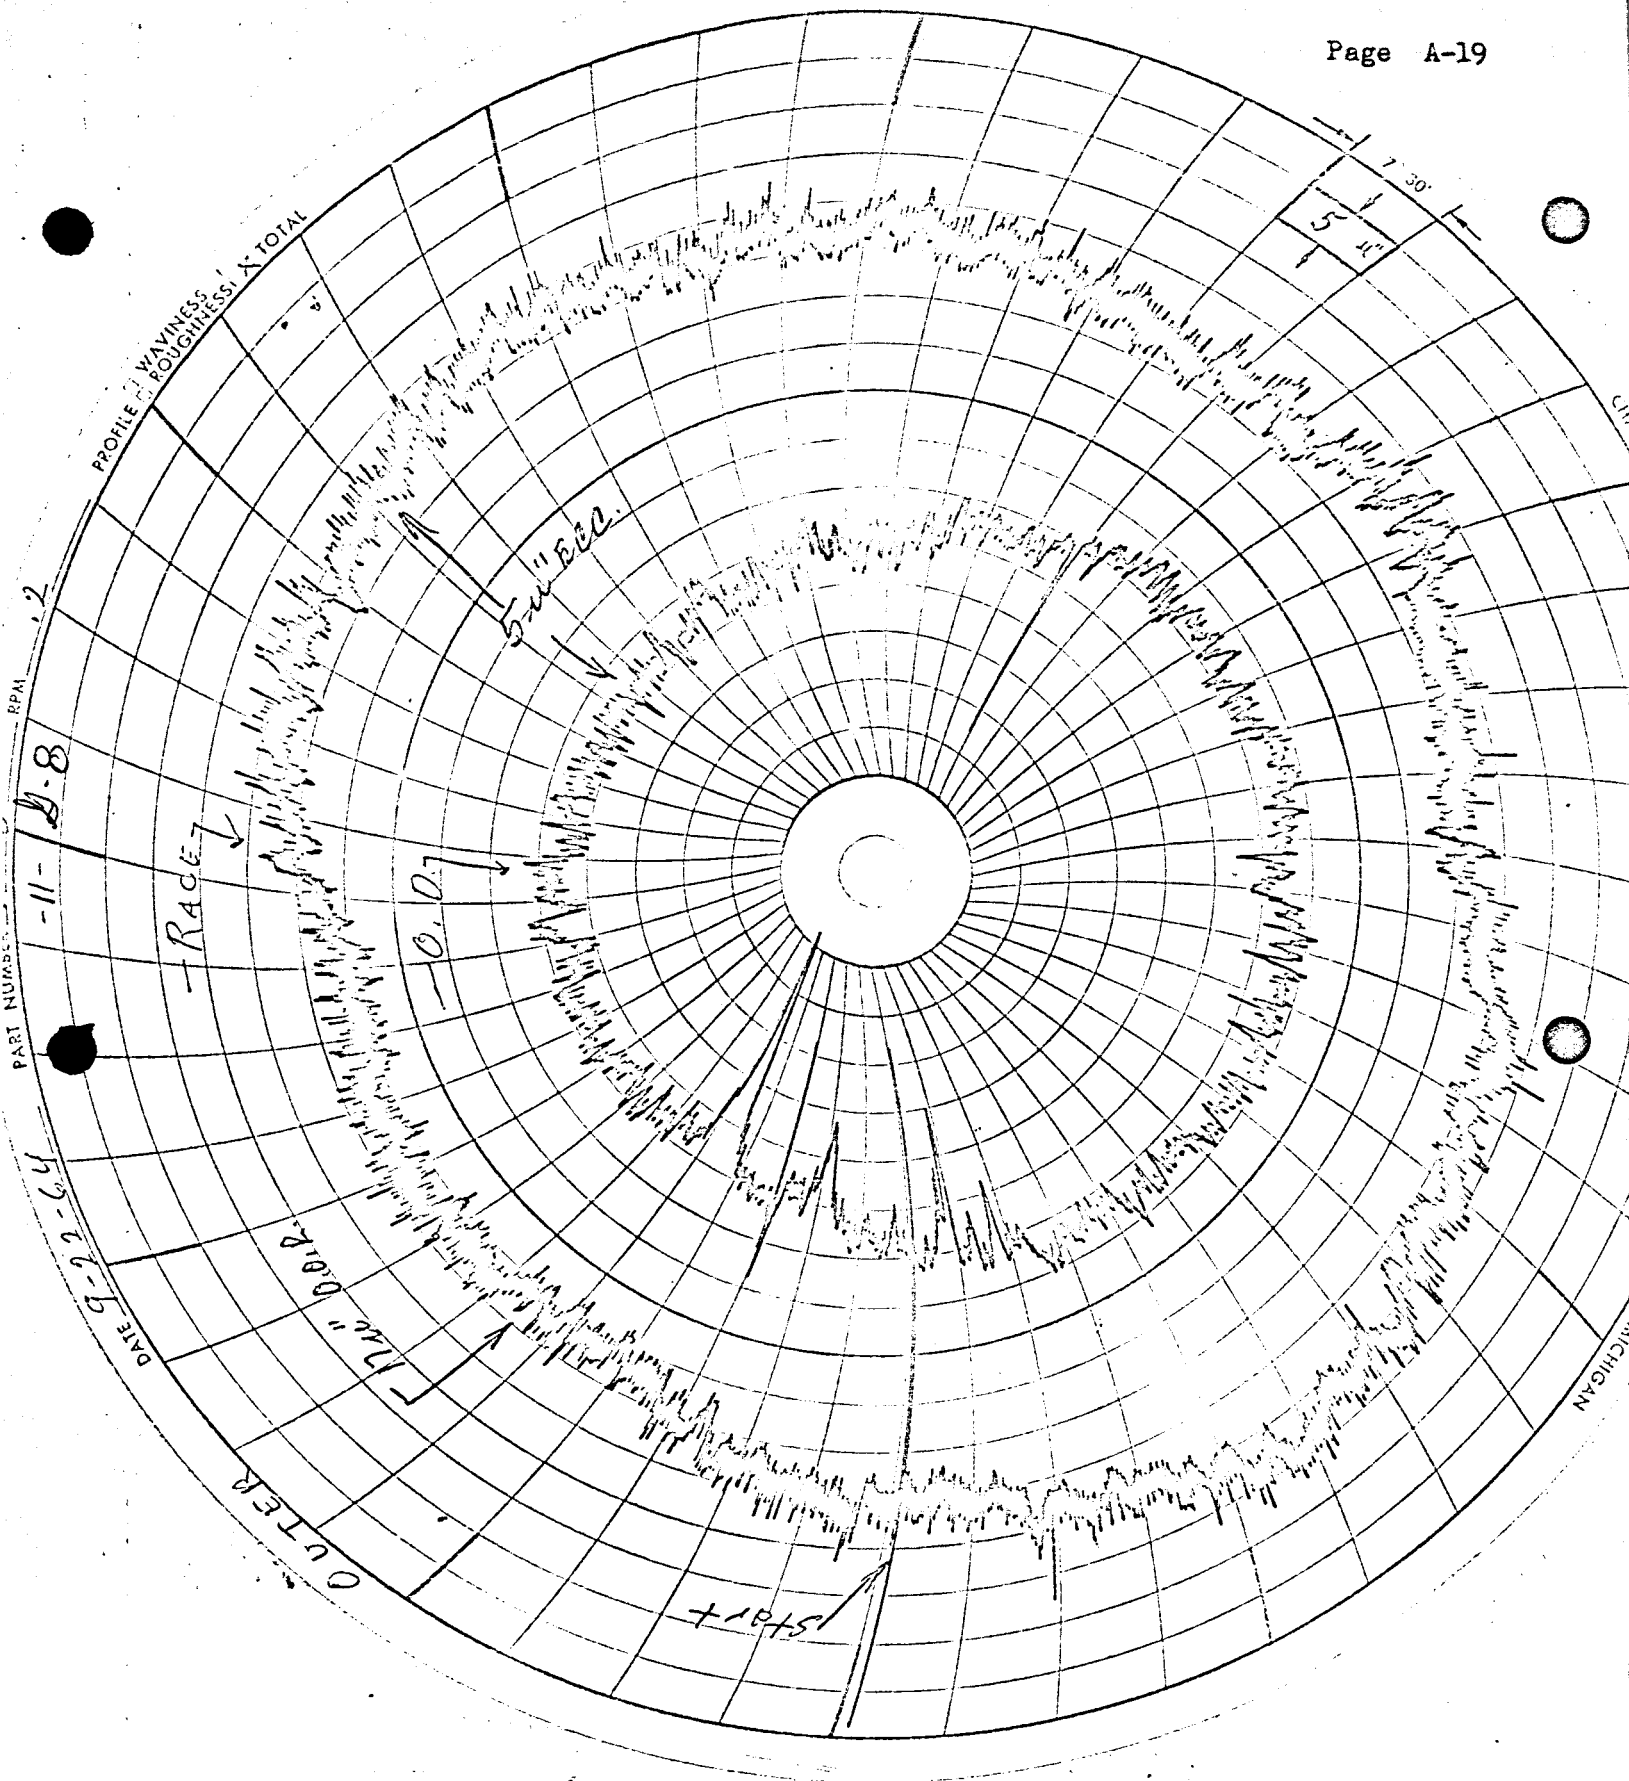
PROFICORDER TRACES OF AN OUTER RACE AND OF O.D. OF OUTER OF
LOT G, BEARING NO. 8

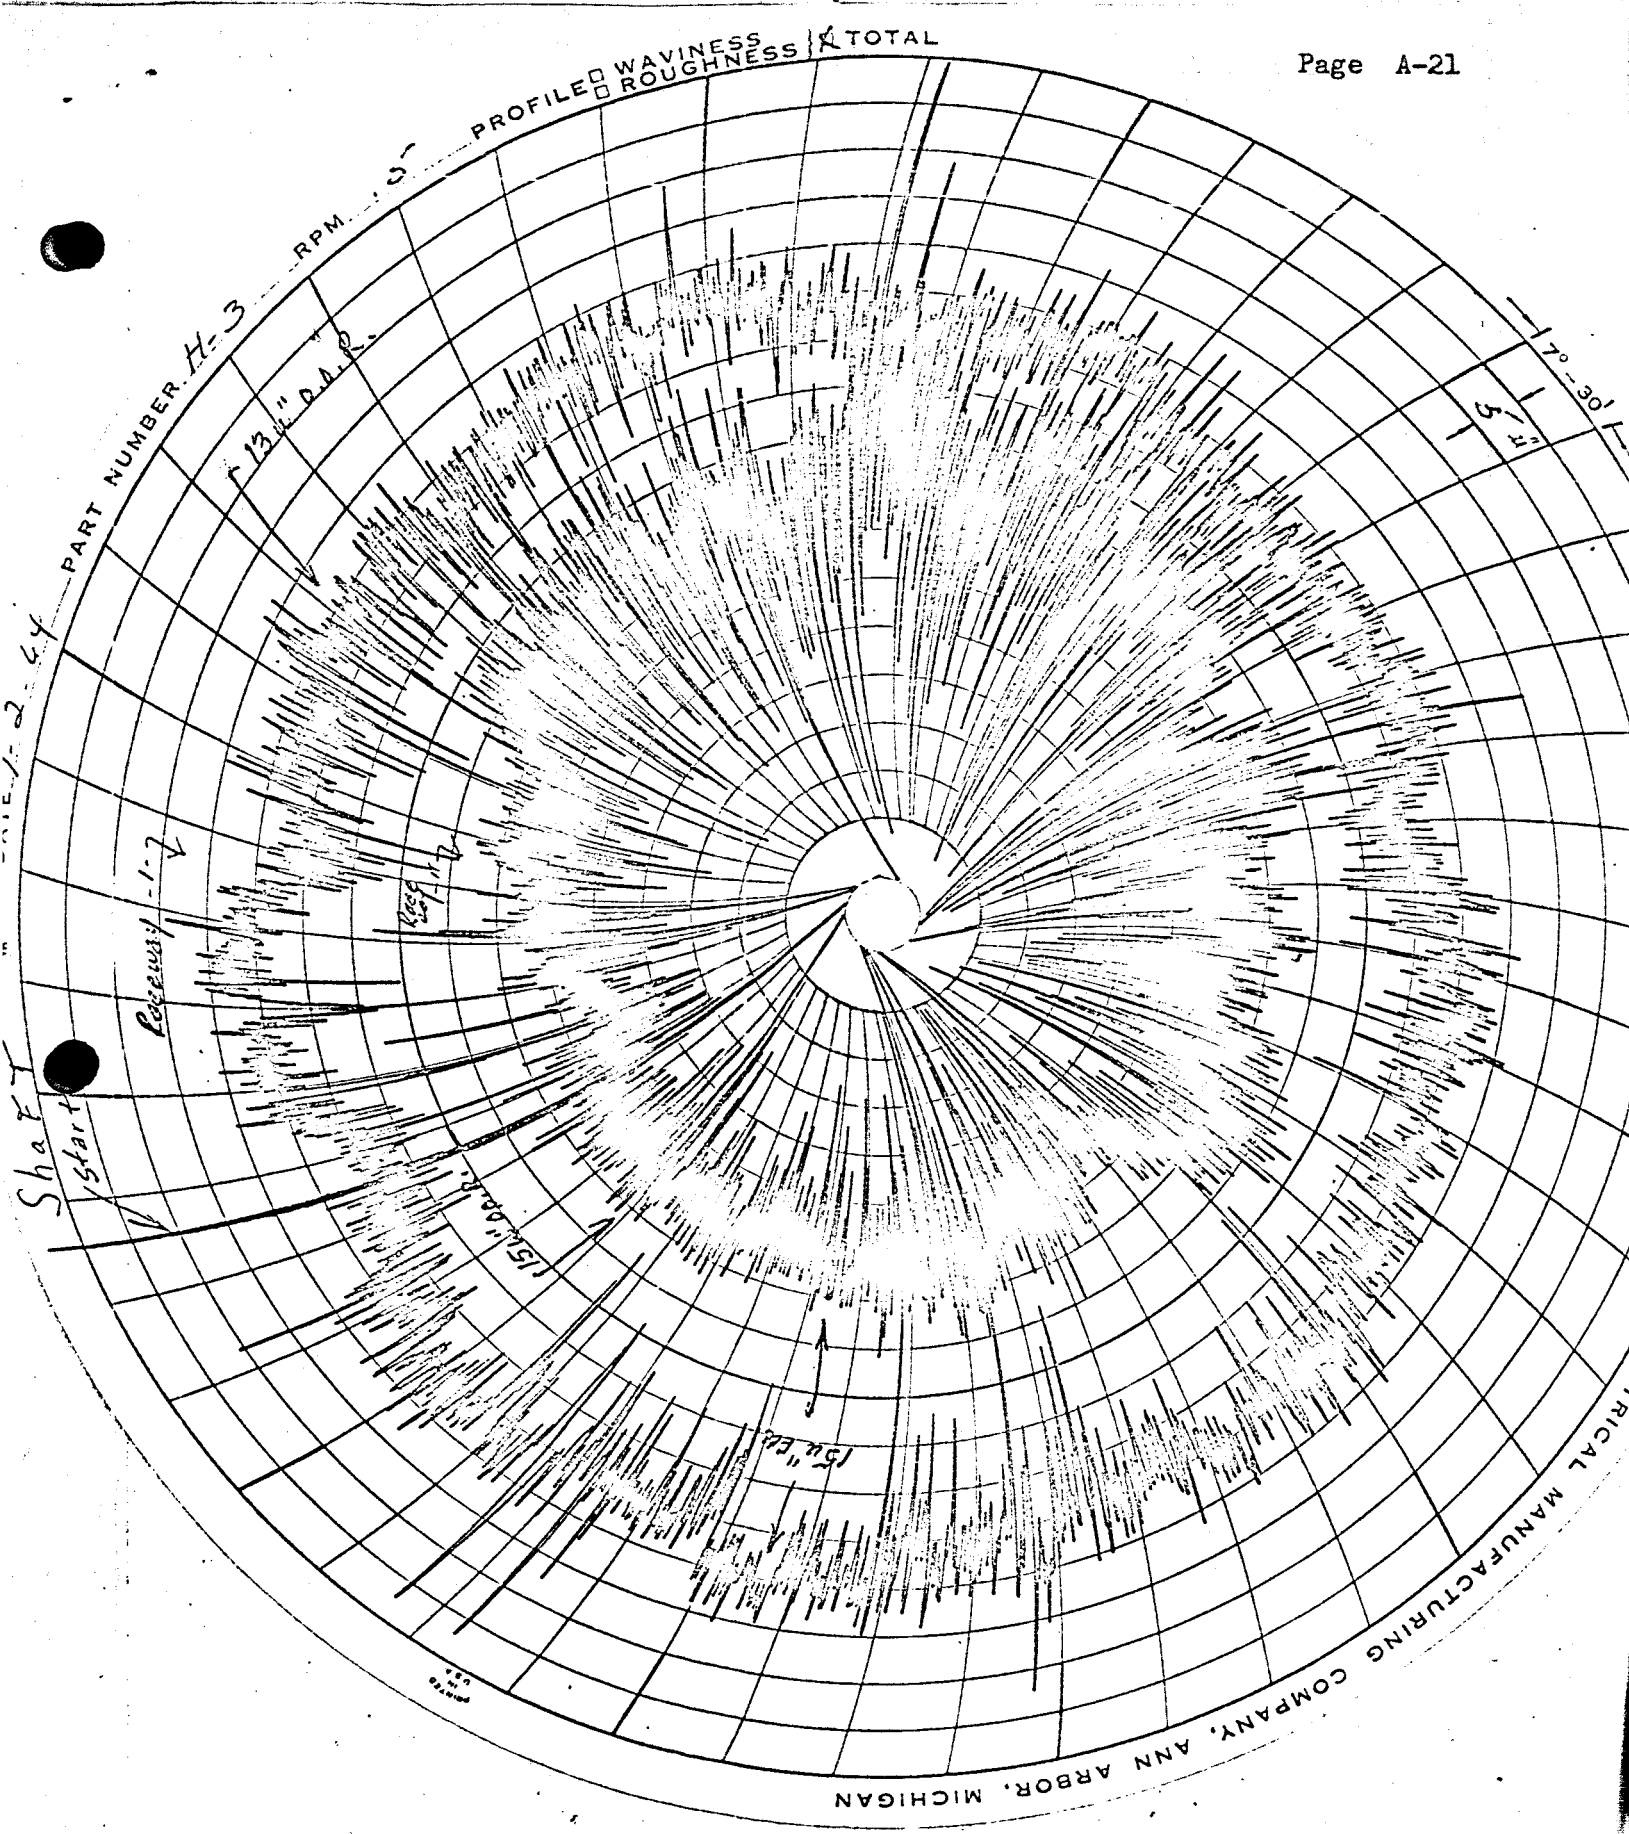
PROFICORDER TRACES OF INNER RACES OF LOT H, BEARING NO. 3

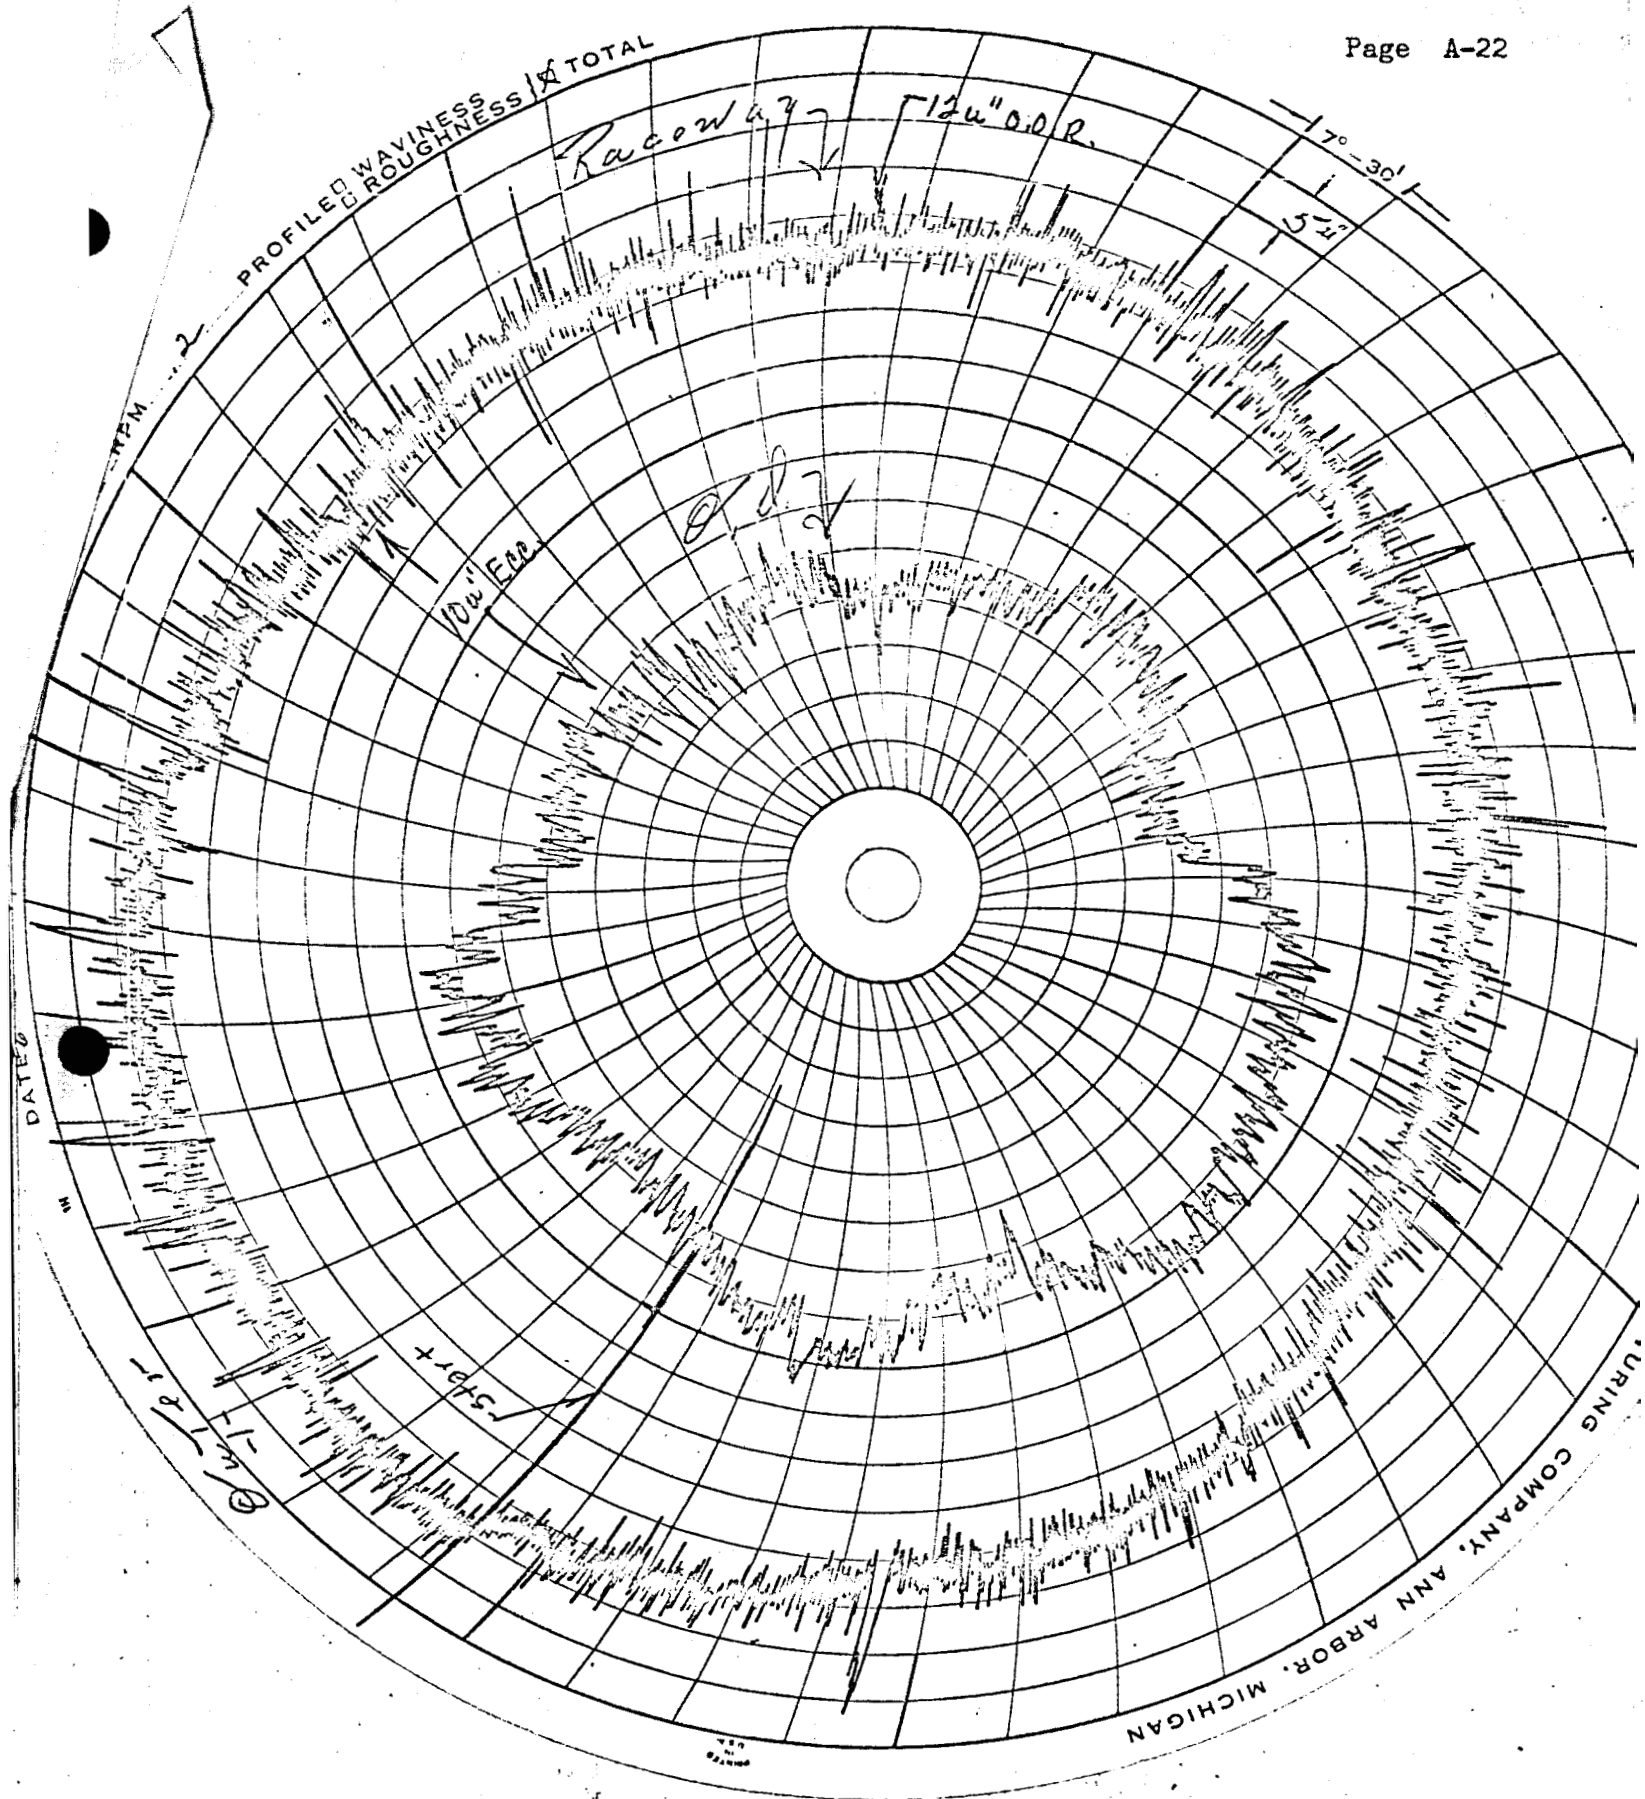
PROFICORDER TRACES OF AN OUTER RACE AND OF O.D. OF OUTER OF
LOT H; BEARING NO. 3

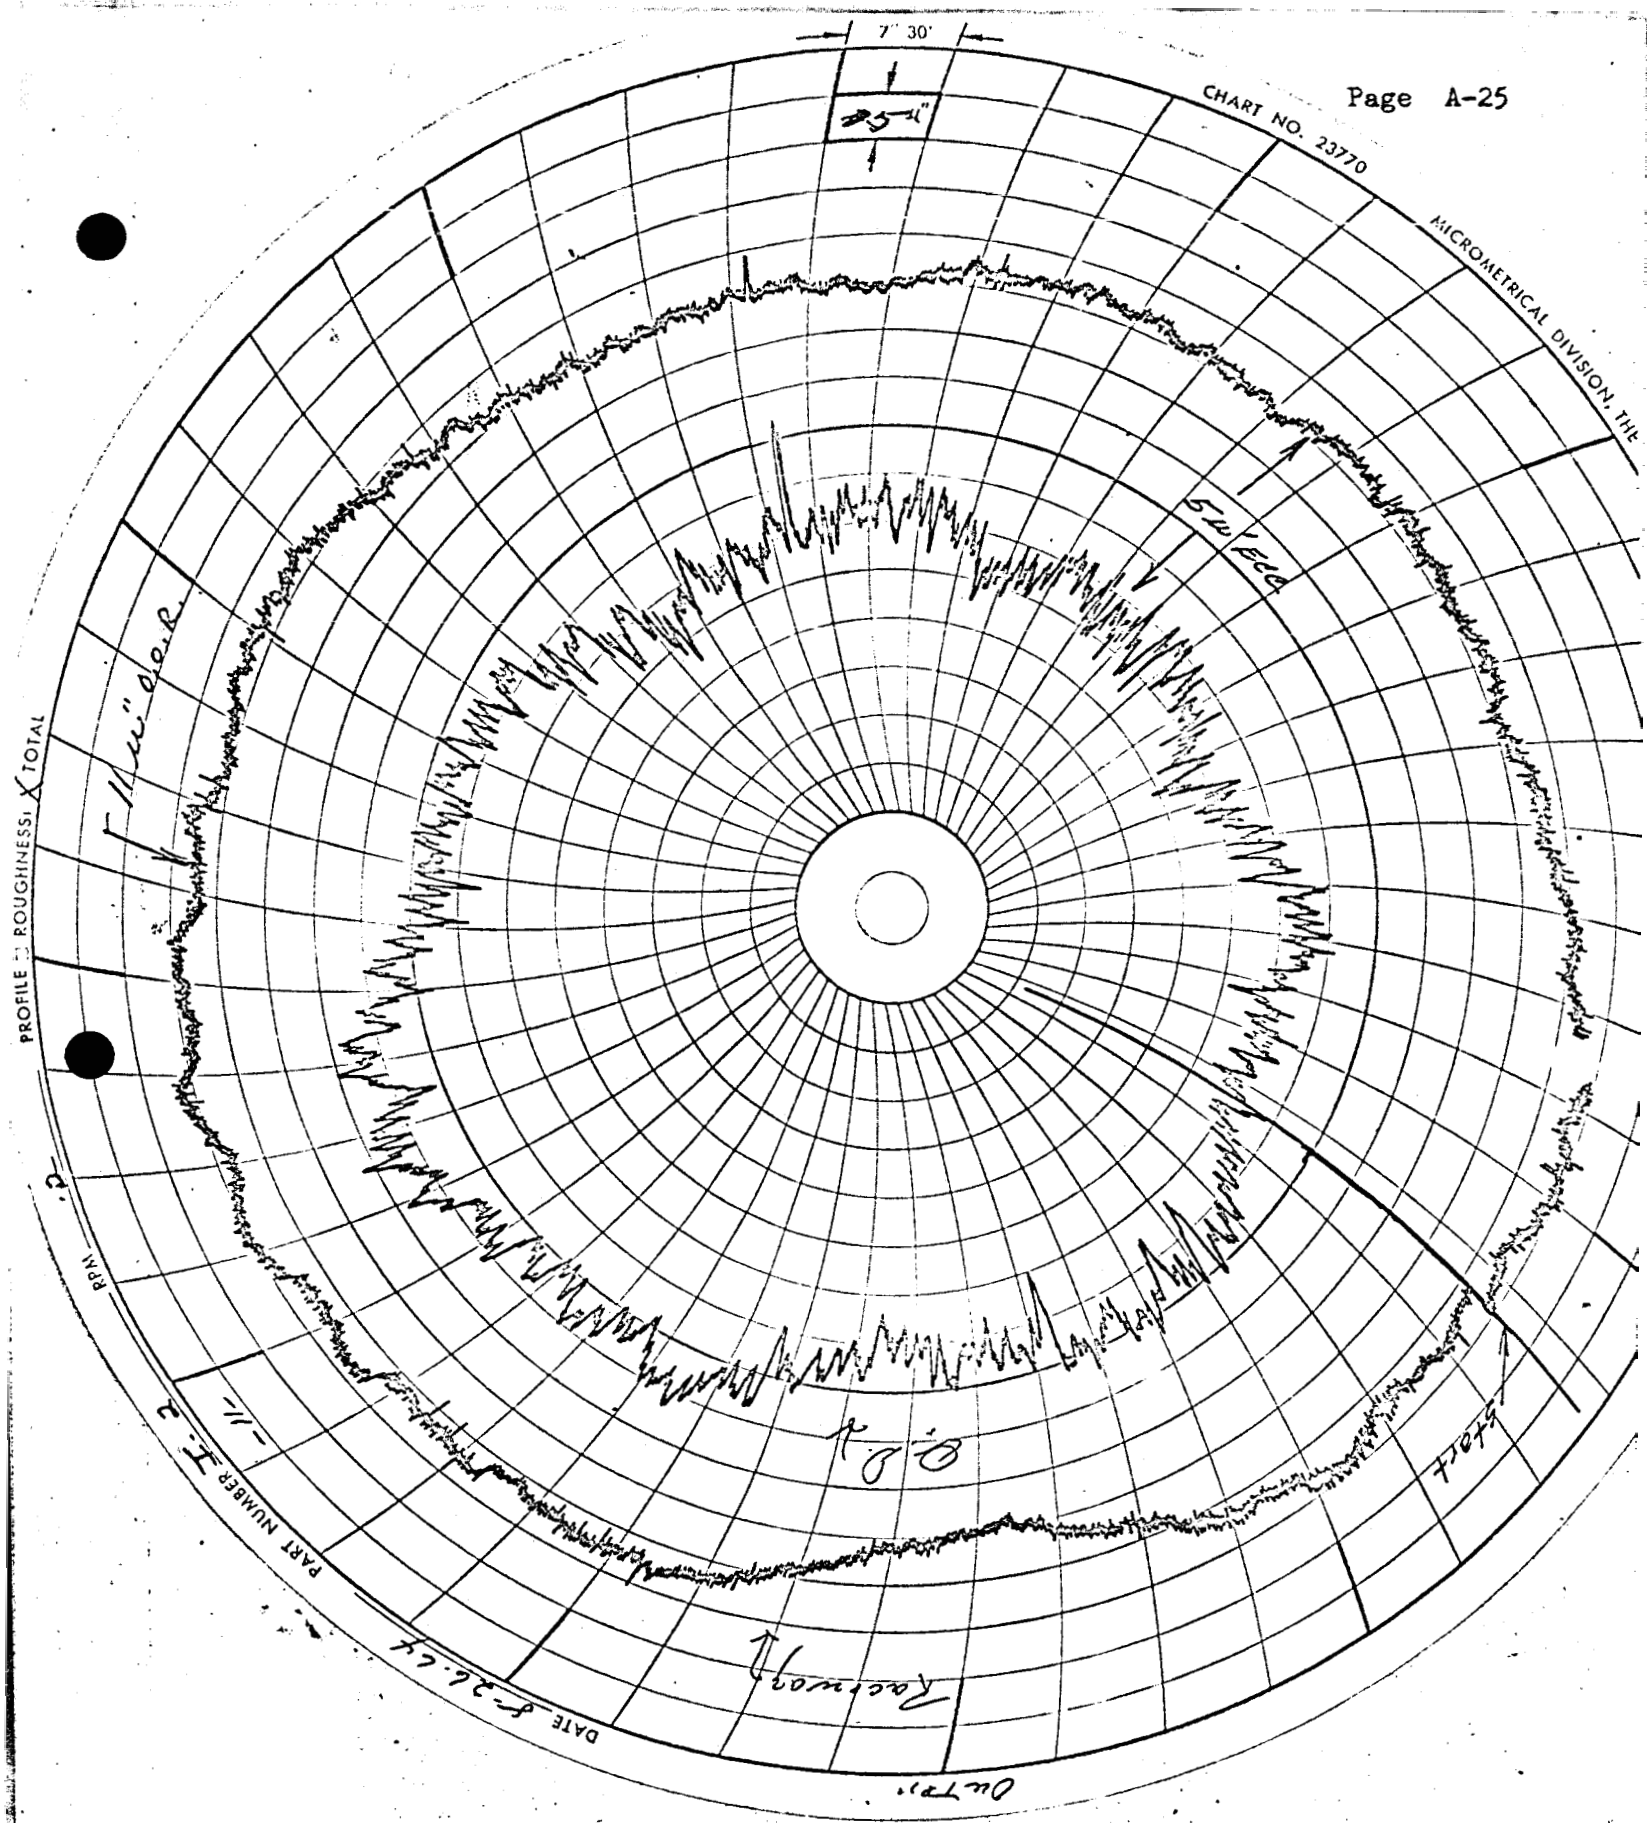
PROFICORDER TRACES OF AN OUTER RACE AND OF O.D. OF
LOT 1, BEARING NO. 2
